UNIVERSITY OF MINES AND TECHNOLOGY

A THESIS REPORT ENTITLED

INVESTIGATING THE FREQUENT BURNOUT OF 33 kV/433 V  
DISTRIBUTION TRANSFORMERS OF ECG

AUGUST, 2020

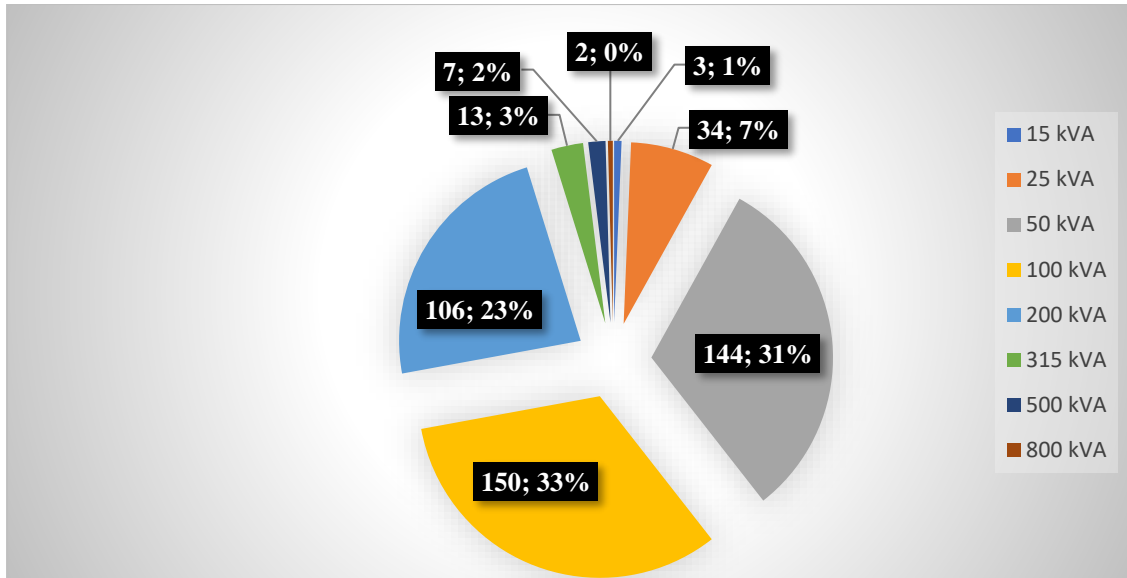
**Figure 1.1 Data on Damaged Transformers Recorded by ECG in 2019**

In 2019, ECG recorded 459 transformers damage nationwide. Out of these, 150 of the transformers were 100 kVA and that represents 33% of the total lost transformers in the year. The next in line was the 50 kVA transformers, where 144 representing 31% of such were lost in that same year. 106 (23%) of the 200 kVA was lost with the remaining 59 recorded on different sizes of transformers. Figure 1.1 shows a chart of the damaged transformers recorded in 2019. Consequently, the company spent GH¢ 11,907,329.57 as cost of replacing these damaged transformers in 2019. A breakdown of the total cost on the various sizes of transformers lost in 2019 is presented in Figure 1.2.

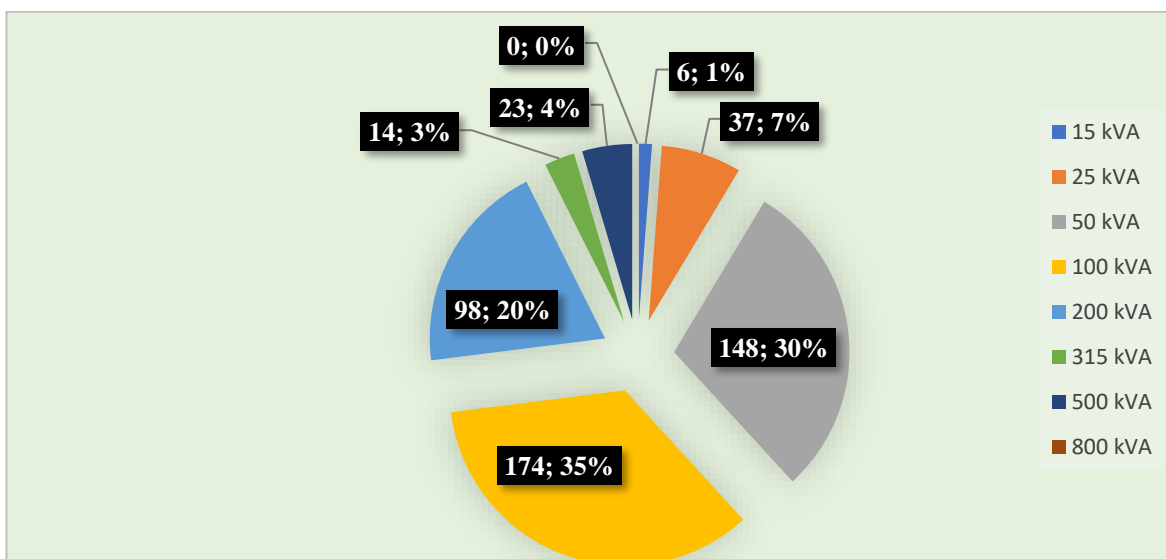
**Figure 1.3 Data on Damaged Transformers Recorded by ECG in 2018**

A similar situation is experienced in 2018, where a total of 500 transformers were lost in that year alone. Out of the total transformers damaged in 2018, 174 representing 35% were 100 kVA transformers. This is followed by 148 of the 50 kVA transformers which represents 30% of the total damaged. 98 of the 200 kVA transformers were lost and the remaining 80 which represents 15% were transformers of other sizes. Figure 1.3 shows a chart of the damaged transformers recorded in 2018. The company spent GH¢ 14,084,326.97 as cost of replacing these damaged transformers in 2018. A breakdown of the total cost on the various sizes of transformers lost in 2018 is presented in Figure 1.4.

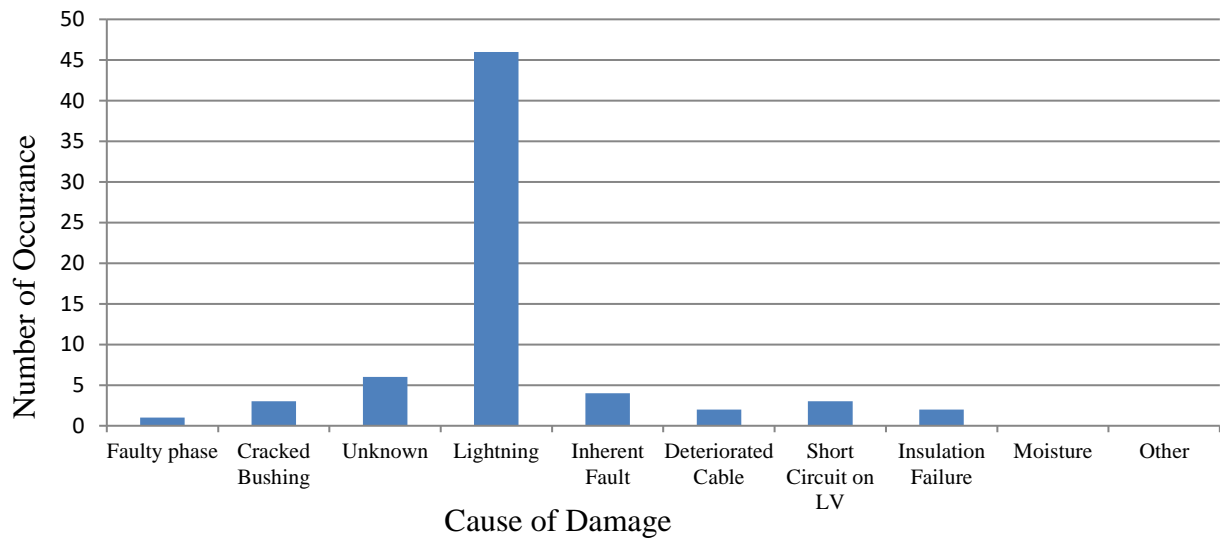
**Figure 3.1 Causes of Transformer Burnout for the Year 2017**

To determine the cause of the most frequent burnout, the transformer failure data sheet is taken from ECG’s Central Region network. The data is presented graphically in Figures 3.1 and 3.2.

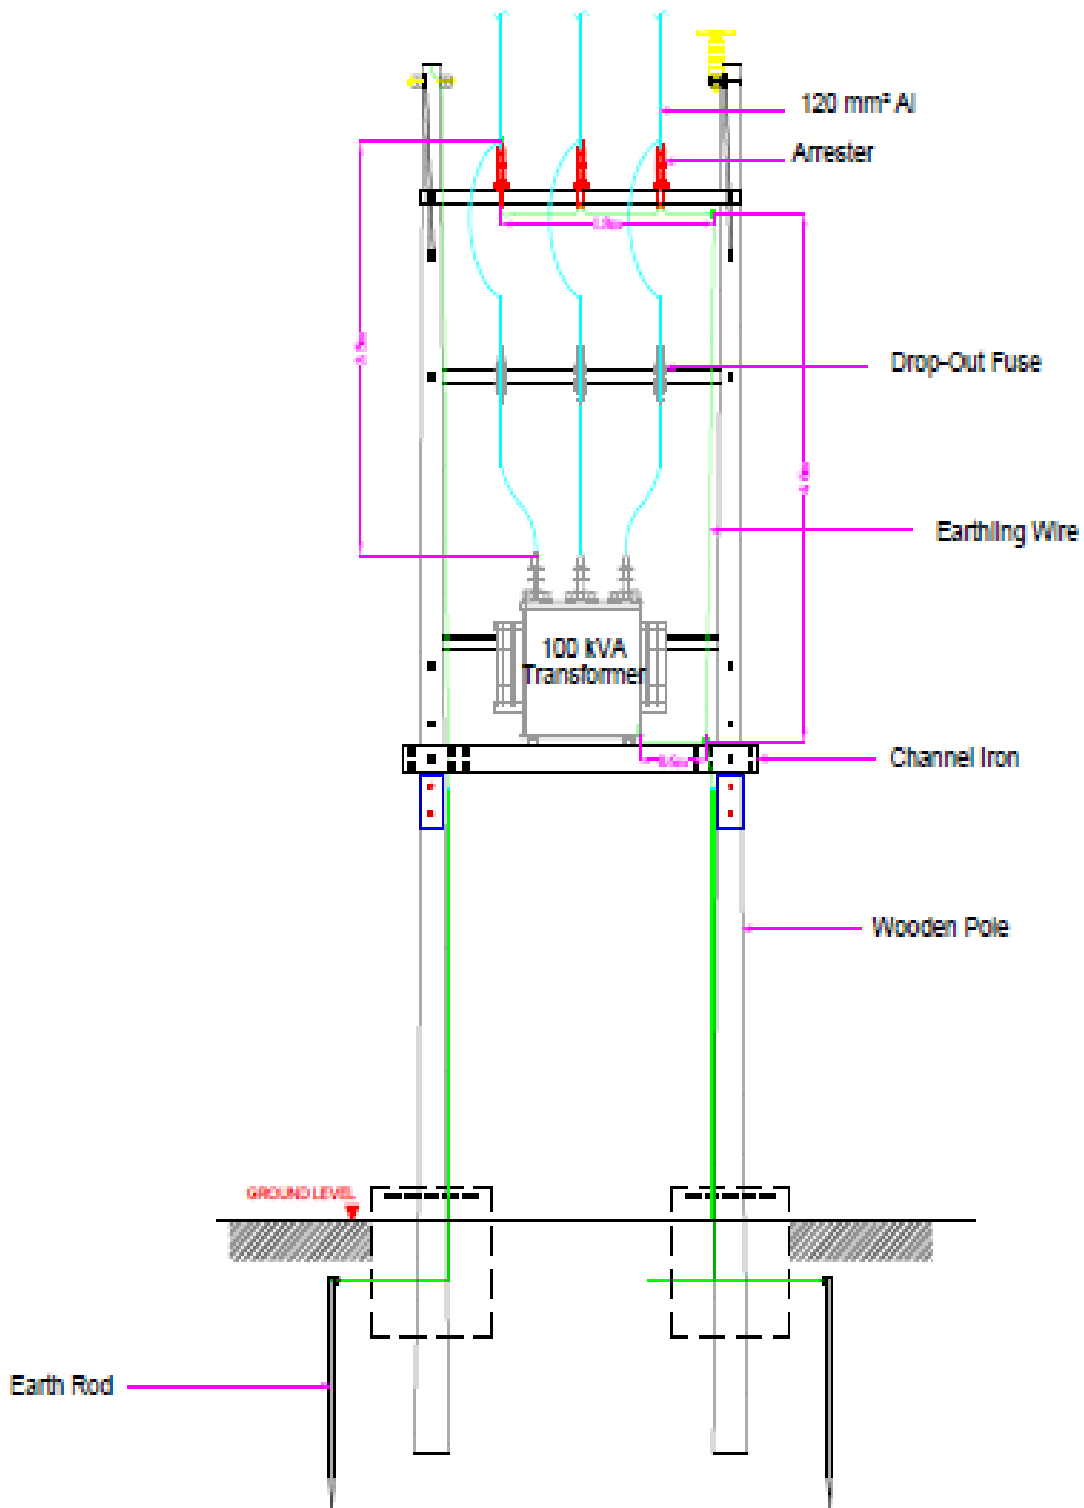
**Figure 3.5 Typical ECG Current Lightning Protection Configuration**

Figure 3.5 shows typical ECG current pole mounted substation and lightning protection configuration.
