## **Environmental and Socio-Economic Effects of Mining Activities in Selected Agro-Mining Communities in Nigeria**

**Opafunso, Z.O. and Daodu, O. A.**

Mining Engineering Department, Federal University of Technology, Akure, Nigeria

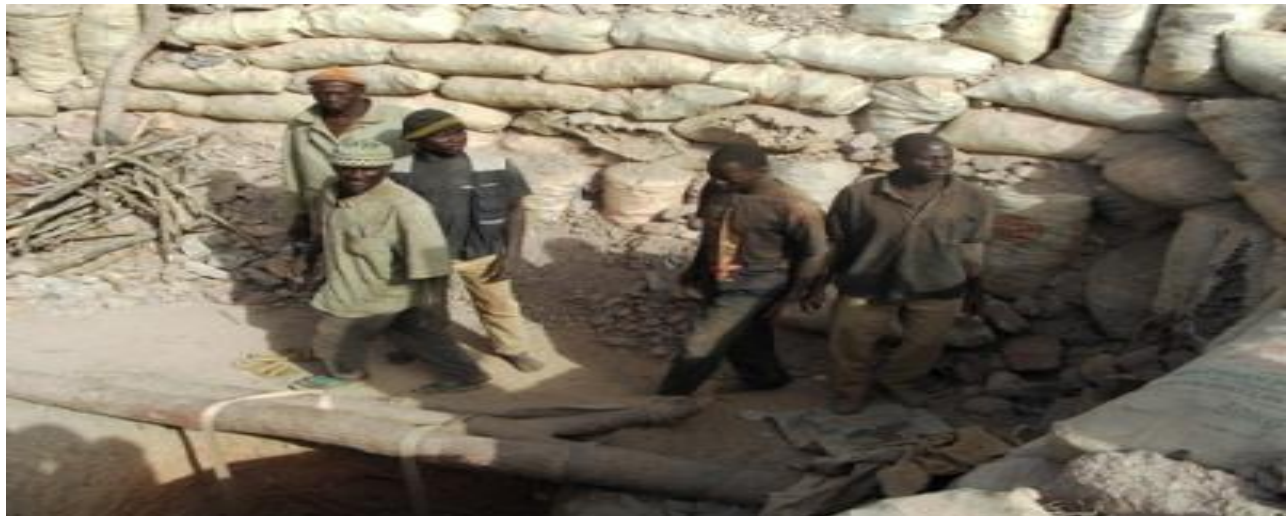
**Plate 1: Destruction of Landscape and Agricultural Land by Illegal Miners of Tantalite.**  
**Mining Site Location:** N09°46'04.3" E008°51'08.1", **Village:** Along Vom Road, Behind Funa Guest Inn, along NDA Base. **LGA:** Barkin Ladi. **Elevation:** 1277m, **State:** Plateau

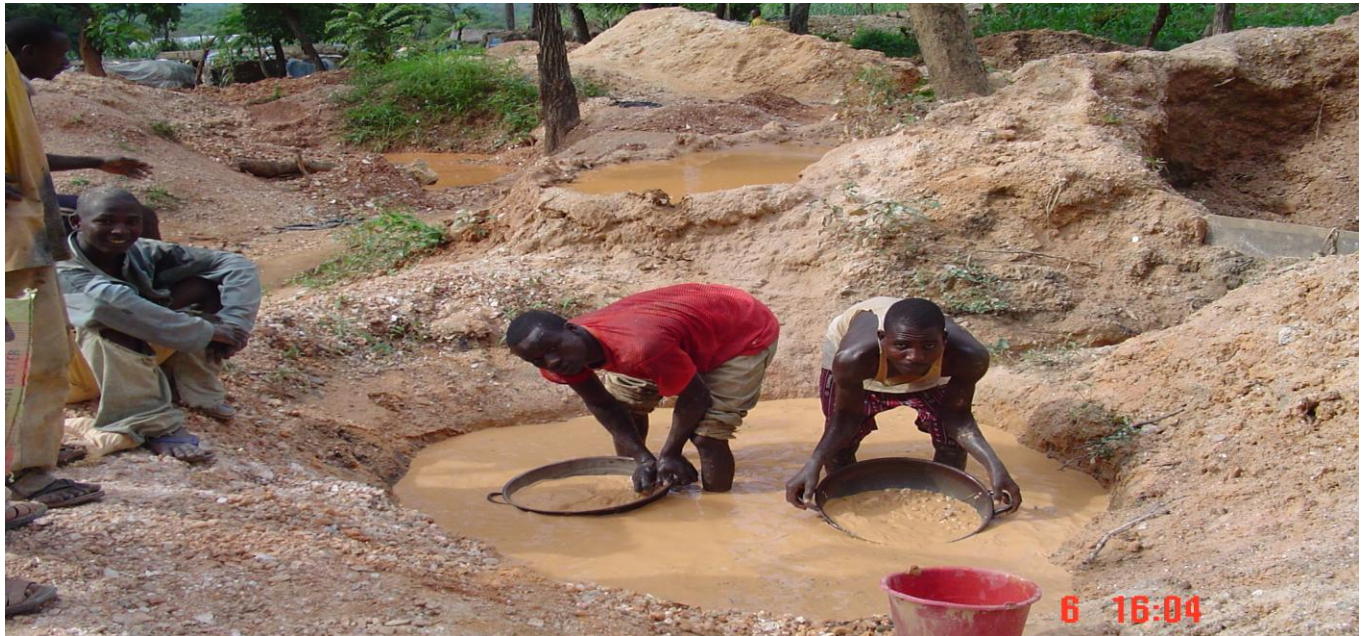
**Plate 2: Destruction of Landscape and Agricultural Land by Illegal Miners of Gemstones Mining. Site Location: Illegal Exploitation of Gemstone, Town: Ofiki, LGA: Atisbo GPS Reading N:  $8^{\circ} 30' .05^{11}$  E:  $3^{\circ} 25' 020^{11}$  Elevation: 139m, State: Oyo**

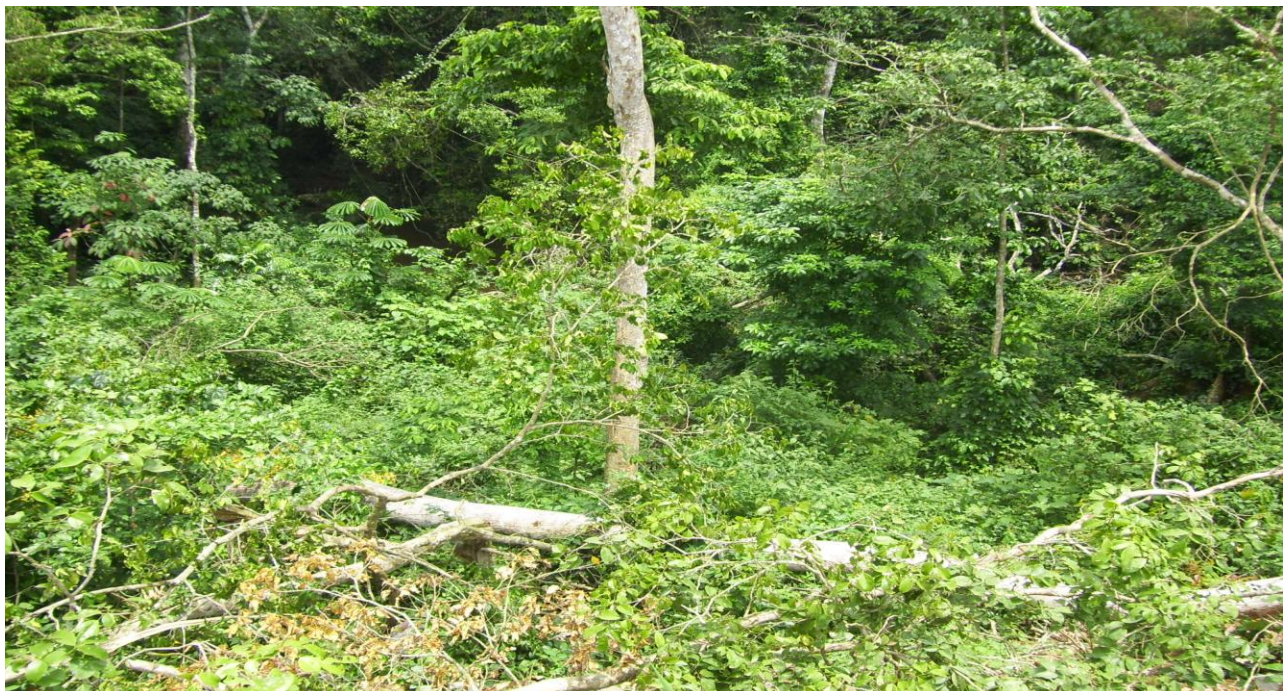
**Plate 3: Destruction of Economic Trees in Agro-Mining Communities. This was caused by Flyrock during Drilling and Blasting of Mining Activities. Village: Petu camp, LGA: Irele. State: Ondo. GPS Reading: N: 06°39<sup>1</sup> 584<sup>11</sup>, E: 004° 54<sup>1</sup> 654<sup>11</sup>**

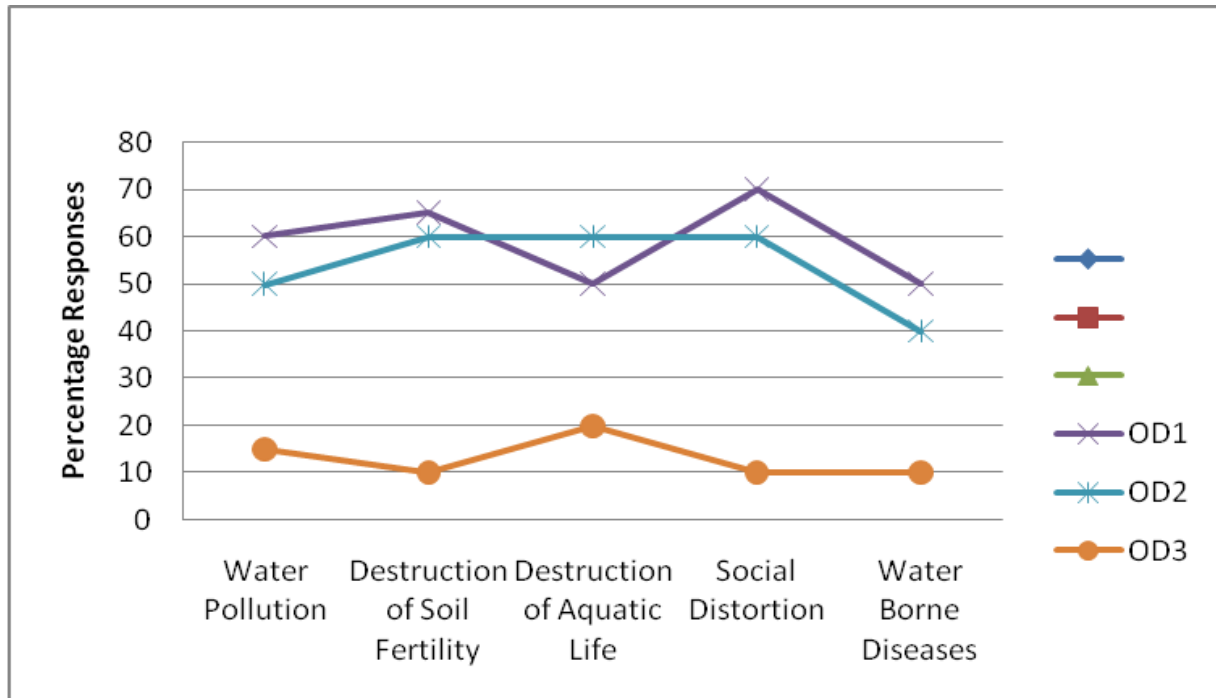
**Fig. 1: Percentages Responses in each location of Ondo State to Environmental Problems**

Residents of host communities of Agro-Mining were interviewed orally by the researcher. Well structured questionnaire were also distributed to respondents in host communities as in Figure 1-4. Responses were impressive and descriptive statistical analysis was used. The percentages of environmental problems confronting the Agro-Mining locations in Petu, Oba Ile and Looda communities are represented with codes (OD1), (OD2) and (OD3) respectively as shown in Fig.1. Similar graph was applicable in Oyo and Plateau State. For example, 60% of the respondents complained of water pollution around Petu. Also, 60% of the respondents complained about the destruction of soil fertility around Oba Ile. It was concluded from Fig.1 that mining activities have significant negative effects on the source of drinking water through surface water pollution, destruction of soil fertility and others environmental problems. All the Agro-Mining locations in the three States were affected except Looda where the effect was not pronounced. This is because mining activities are not regularly carried out yet in that location.

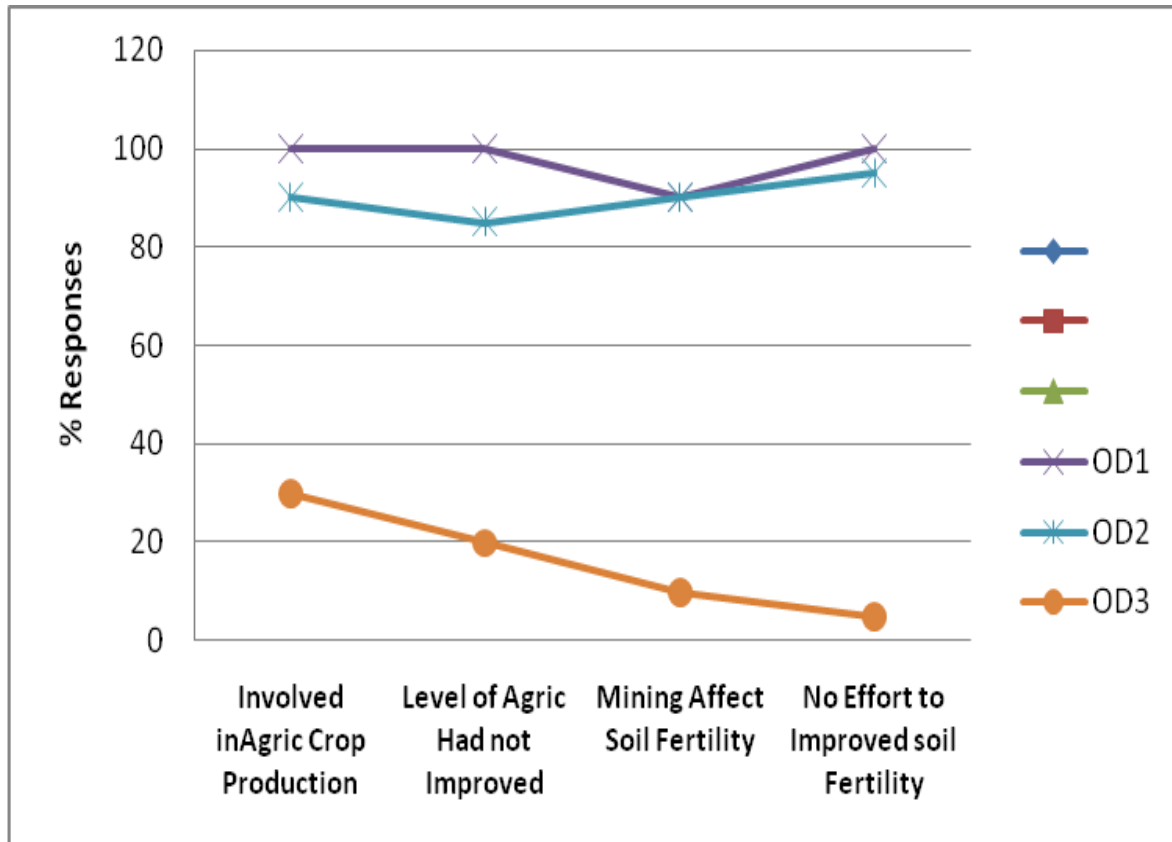
**Fig. 4: Percentages Ranking of Agricultural Issues around the Agro-Mining Locations**

The percentages of agricultural problems confronting the Agro-Mining locations in Petu, Oba Ile and Looda communities are represented with codes (OD1), (OD2) and (OD3) respectively as shown in Fig. 4. For example, 100% of the inhabitants were involved in agric crop production which had not improved since the incident of mining around the Agro-Mining Community in Petu. Also, 85% of the respondents complained that mining affects their soil fertility around the Agro-Mining Community in Petu and Oba Ile. Reports show that agricultural activities had not improved in the selected locations of Ondo, Oyo and Plateau States since incident of mining began and that mining reduced the size of the cultivable land.
