UNIVERSITY OF MINES AND TECHNOLOGY

A THESIS REPORT ENTITLED

INVESTIGATING THE FREQUENT BURNOUT OF 33 kV/433 V  
DISTRIBUTION TRANSFORMERS OF ECG

AUGUST, 2020

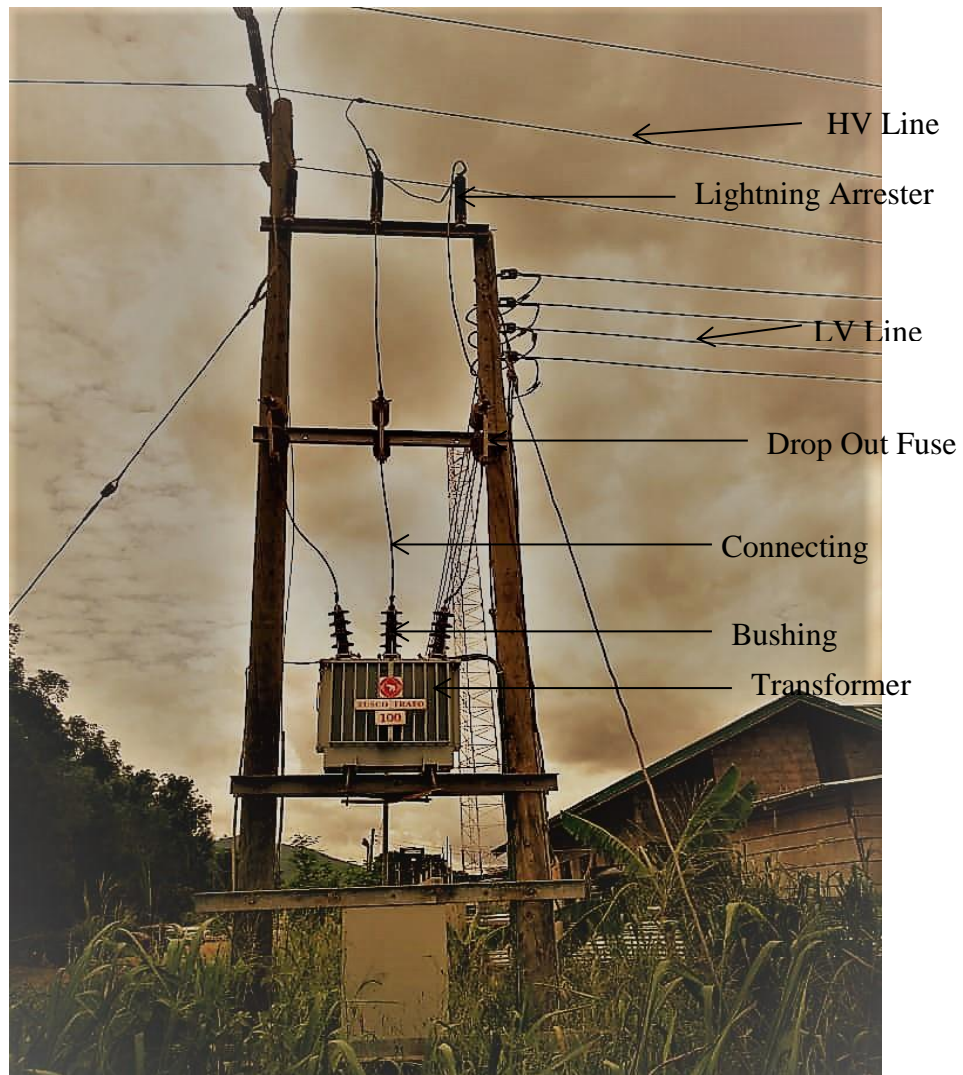
**Figure 3.4 ECG Pole Mounted Substation Configuration  
Employed by ECG**

From Figure 3.4, the channel iron serving as base for the arrester is placed 1.5 metres from the high voltage line. The Drop-out fuse is then placed 3.5 metres from the line and the transformer is at a distance of 6.5 metres from the line. Table 3.1 shows some data collected on the field about Transformer burnouts due to lightning and their measured arresters lead length from some selected distribution substations at Kasoa district.

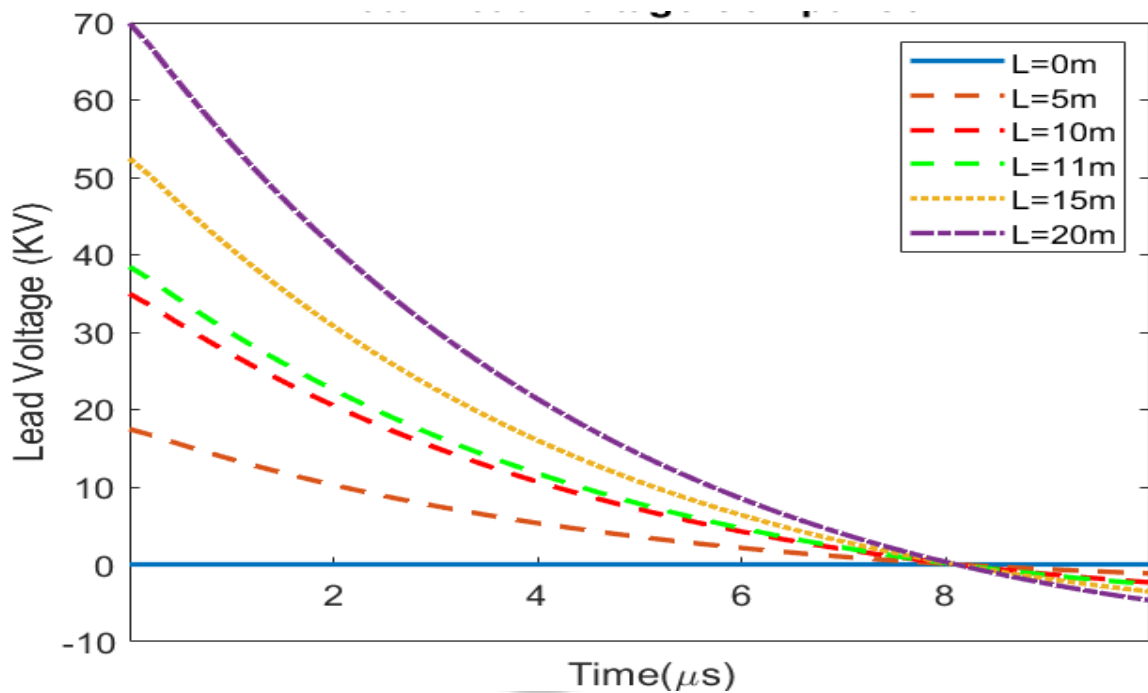
**Figure 4.2 Total Lead Voltage Comparisons**

From Figure 4.2, the voltage contribution of each scenario is shown. The length with the highest value contributes the most voltage to the system and the zero lead contributing no voltage to the lightning surge.

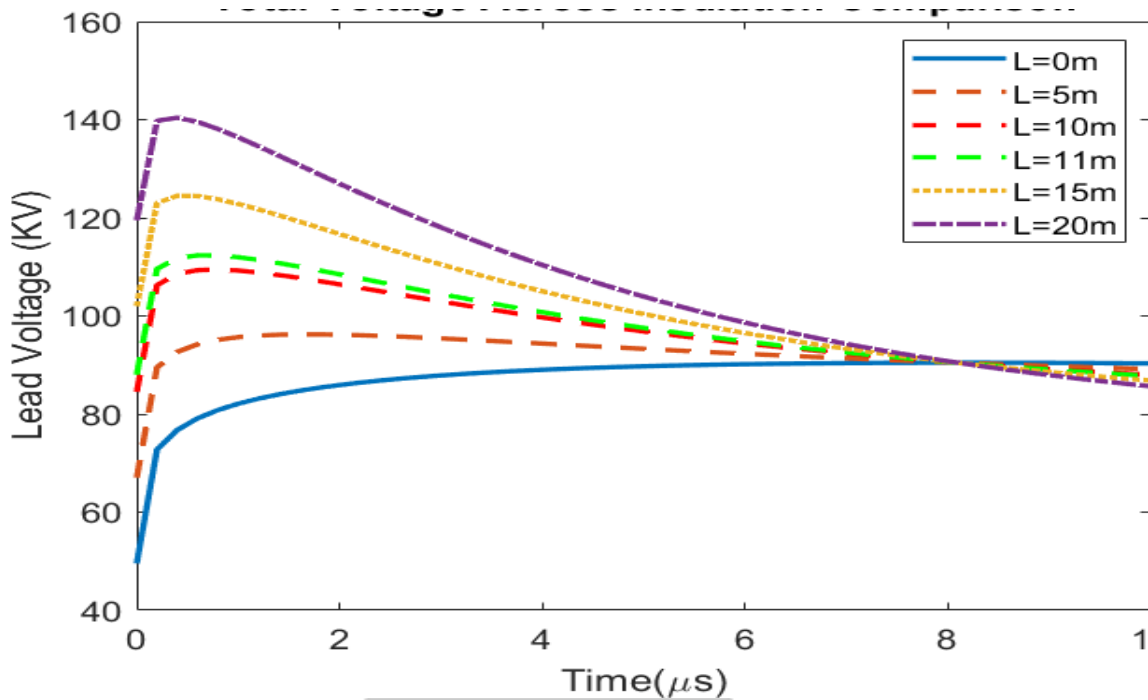
**Figure 4.3 Total Discharge Voltages**

From Figure 4.1 to Figure 4.3, the graphs show that arrester lead length increases the discharge voltage during lightning or voltage surge. It also shows clearly that, the longer the lead length of surge arresters, the higher the discharge voltage across the insulation of the transformer. Also, the higher the discharge voltage across the insulation, the smaller the margin of protection (protective level) putting the transformer at risks and a possibility of transformer damage

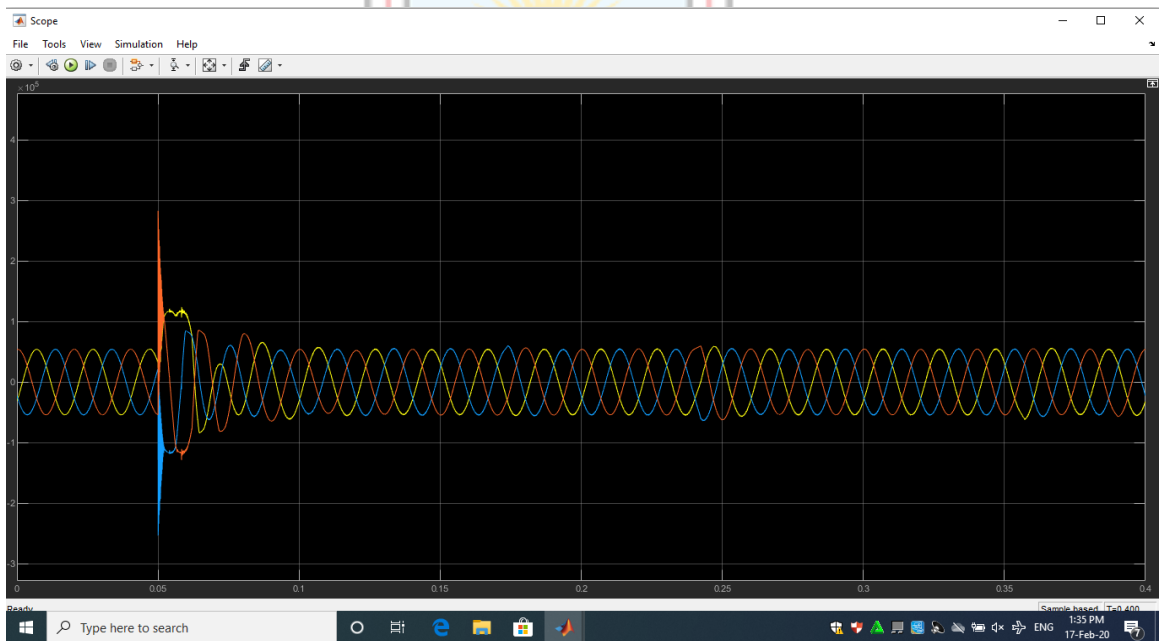
**Figure 4.5 Simulation Results on Lightning Condition of Current Configuration**

From Figure 4.5, the magnitude of the surge discharge voltage across the transformer insulation before the arrester operated was about 120 kV compare to the arresters discharge of 90 kV. This means that the arrester lead length has contributed a discharge voltage of 30 kV.

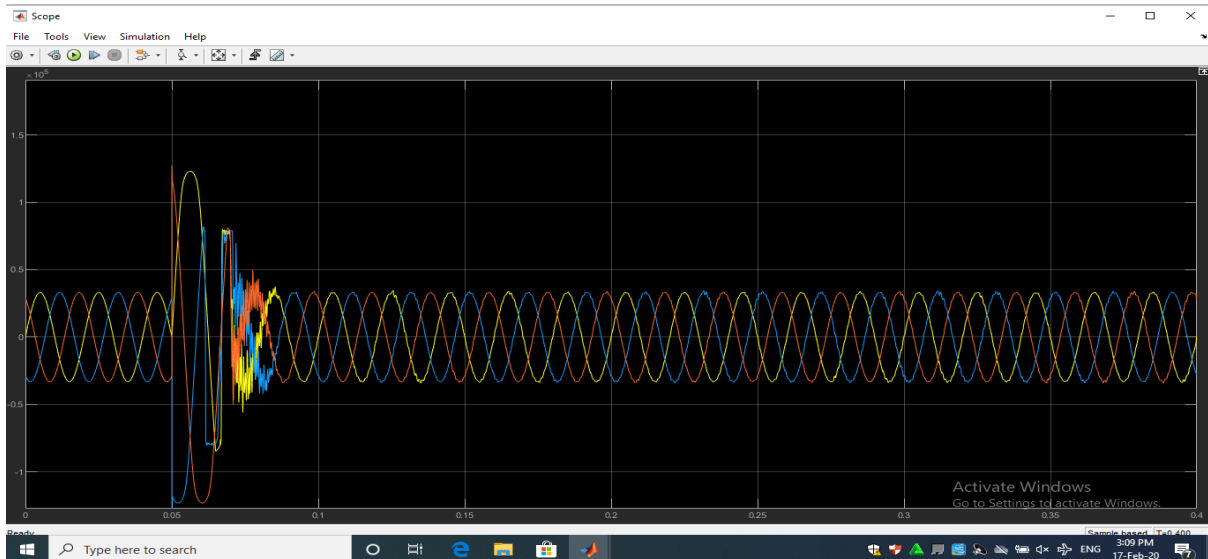
**Figure 4.6 Simulation Results on Lightning Condition of Proposed Zero Lead Length Configurations**

From Figure 4.6, the magnitude of the surge discharge after the arrester operated is about 85 kV compare to the arresters discharge of 90 kV. This means that without the arrester lead length, there is less discharges across the transformer insulation compare to arrester with lead length as shown in Figure 4.5 and Figure 4.6, respectively.
